# DIPLOMARBEIT

„Adequacy of design and management of a new  
livestock watering source (Wanzogi, Uganda)“

Wien, 2014

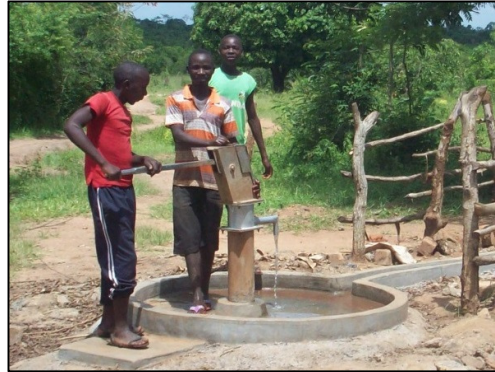
Figure 6: Kanyonyi village borehole

Most boreholes never dry up and for that reason some cattle keepers use them as a water source. Especially farmers with only a few head of cattle often go to the boreholes during dry season. However, this is not an option for the bigger herds as pumping groundwater takes a long time and access is limited. Some boreholes have the rule that cattle keepers are only allowed to water their animals during night hours to make sure fetching water for domestic use is not restricted during daytime.

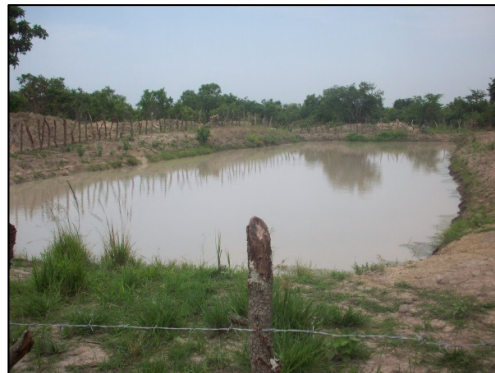
Figure 7: Kainamura private valley tank

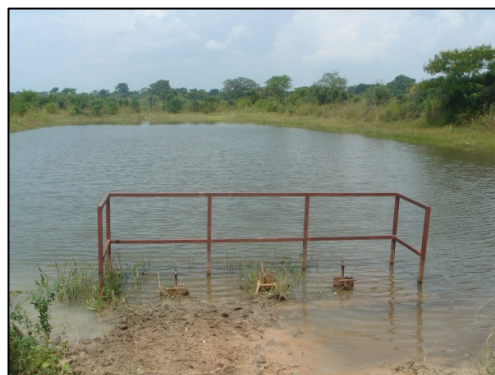
Figure 8: Kisweramayinda communal valley tank

who have run out of alternative water resources, walk to water their livestock and thus is essential for a valley tank's cattle catchment area. Some communal valley tanks run dry during dry season, while others never dry up. The reason why some valley tanks don't dry up even while there are cattle having to move to Lake Kyoga at the same time is that every valley tank only provides a certain area for grazing animals. Consequently the number of animals at one valley tank is not only restricted by the amount of water, but also by its surrounding grazing / resting area.

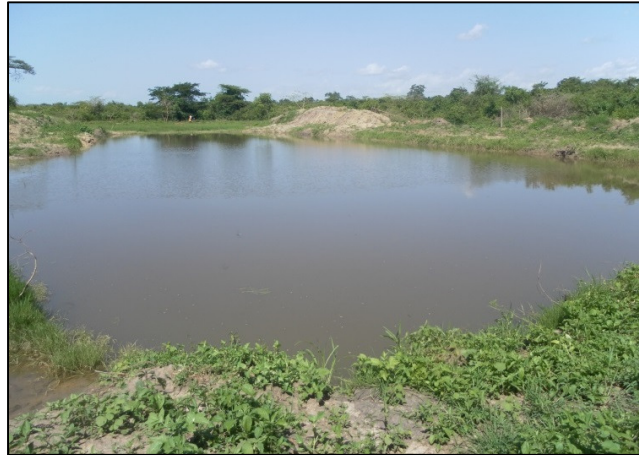
Figure 9: Wanzogi valley tank

To determine the adequacy of the Wanzogi valley tank (displayed in Figure 9) in regards to water quantity, it is essential to take a closer look at the water balance. The terms of the water balance are the water provision represented by the *catchment yield* of the valley tank's drainage area, the local *water*

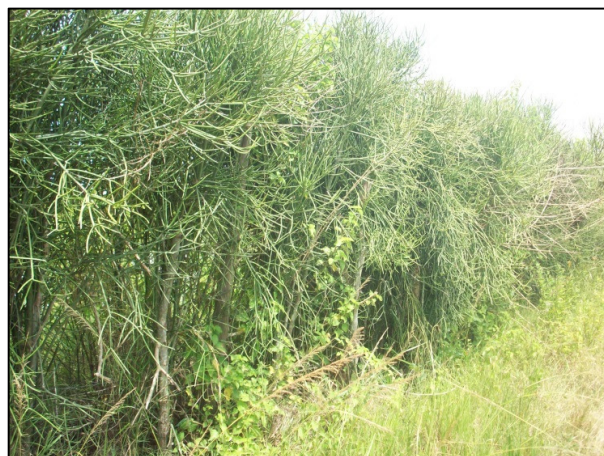
Figure 10: Lukoni live fence (Kisweramayinda)

Fencing is suggested in almost every handbook, yet Pallas (ibid.) mentions that in developing countries fencing often increases the costs, maintenance requirements and makes watering the herds more difficult to an unreasonable extent. Additionally fences are removed by herdsman being considered an unjustified obstacle or simply trampled by thirsty herds during dry season. To provide a fence that lasts and resists animals at reduced costs, the planting of a live fence as displayed in Figure 10 may be

preferable to a barbed wire fence (WAC 2005: 92). In the Nakasongola district, a drought-resistant plant called Lukoni has proven to be adequate as a live fence in combination with barbed wire.

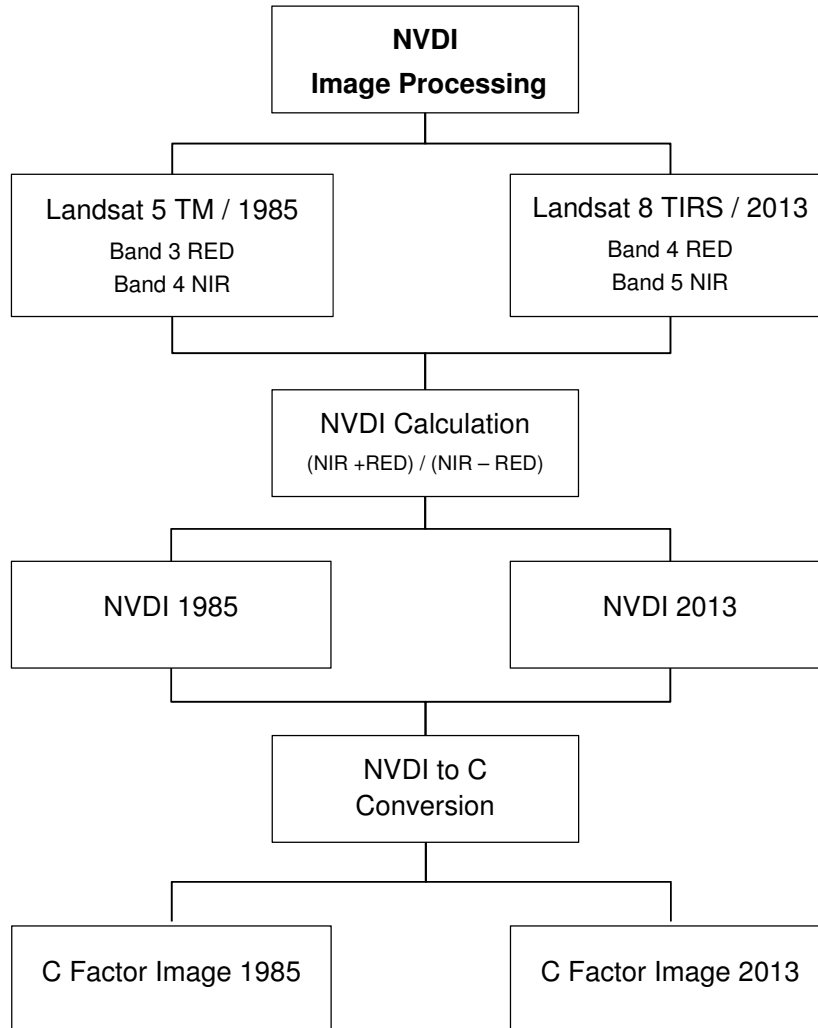
Figure 11: NVDI image processing flow chart (adapted from Agone and Bhamare 2012: 4)

Figure 11 displays the work flow of NVDI image processing. Additionally a supervised classification was performed for 2013 to confirm the reliability of the NVDI calculation. Classification was done with the World Imagery provided by ArcGIS 10; the corresponding classes are listed in Table 4. Once the training samples taken from the images were transformed into polygons representing the classes, a maximum likelihood classifier was used to transform the Landsat image into land use classes. During fieldwork additional training samples of these classes were recorded with GPS and used as training samples for the classification. For each class at least 10 GPS records were taken in the field, with the exception of forest. Due to the severe forest degradation it was basically impossible to locate enough sites that can still be

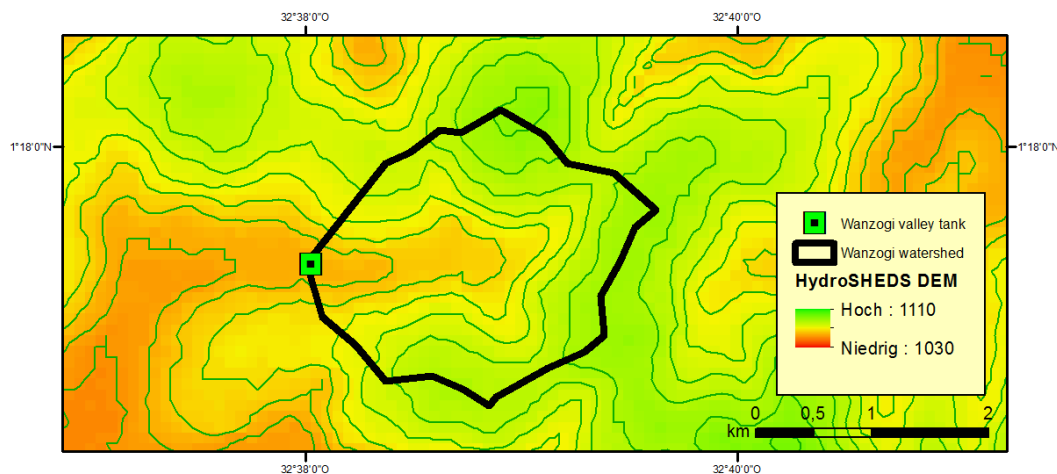
Figure 15: DEM of the Wanzogi watershed

The HydroSHEDS DEM allowed calculating the size of the Wanzogi watershed, which was determined to equal 4.127 m<sup>2</sup>. The watershed is displayed in Figure 15.

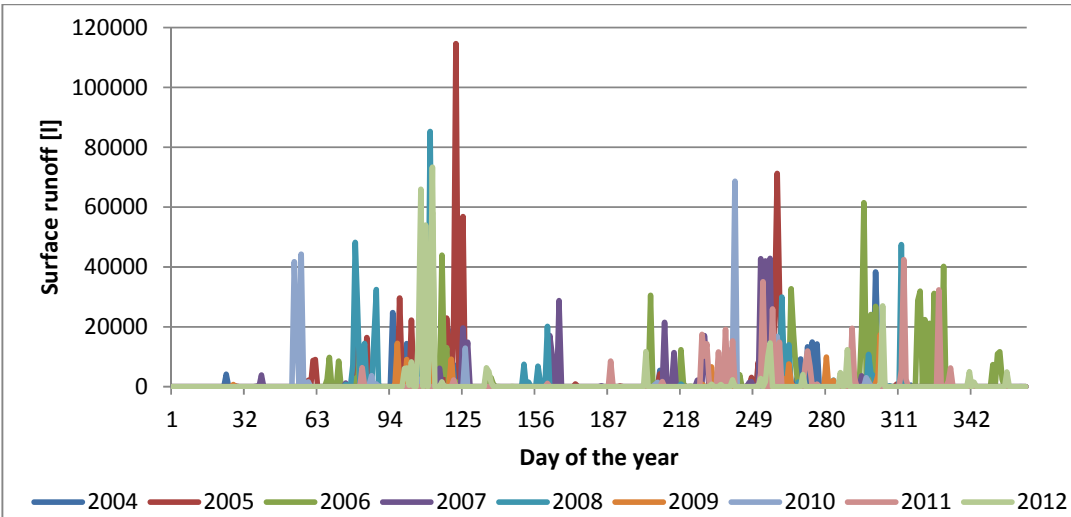
Figure 17: Seasonality of surface runoff

The result of calculating the surface runoff with the SCS curve number method is shown in Figure 17:

The seasonal changes in runoff are evident, and as the farmers stated, the long dry season at the beginning of each year is the biggest challenge for watering livestock. For all years observed, this dry season was longer than the one around mid-year. Due to the impossibility of calibrating the model, the absolute runoff numbers are likely to be exaggerated. Onyando and Sharma (1995: 374) have shown that not calibrating an SCS/CN model in similar conditions in Kenya led to a runoff overestimation by a factor 10. Considering the volume of the valley tank, even this overestimation suggests, that the area is frequently flooded during the rainy seasons. This fact was confirmed by the locals.

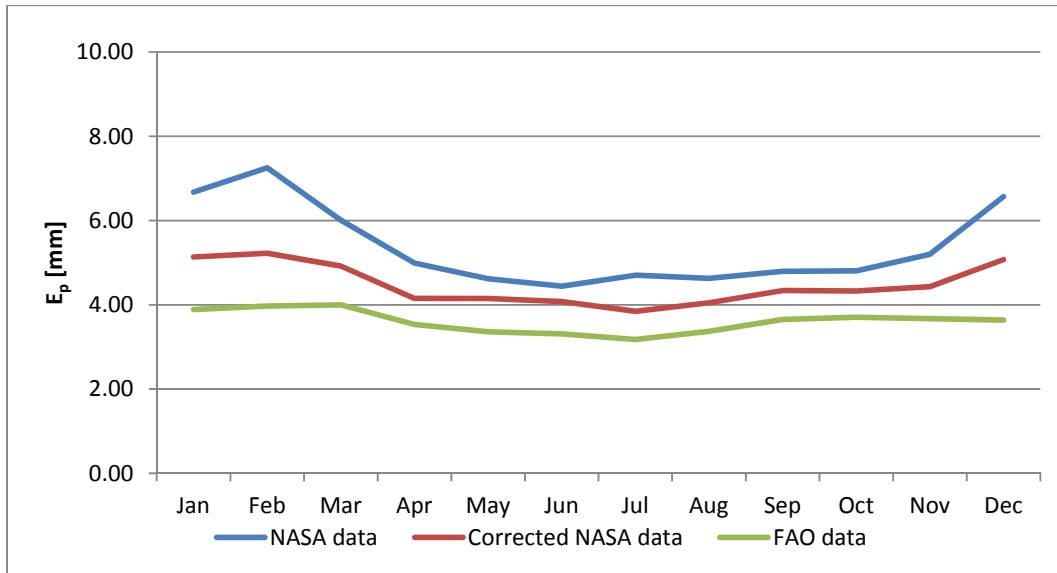
Figure 18: Corrected NASA data at Wanzogi

Figure 18 shows that the corrected NASA data at Wanzogi is still significantly higher than the interpolated FAO data, but well below the original NASA estimates. Figure 19 visualizes the correlation of NASA data for Lira, Soroti and Wanzogi as well as the correlation of FAO data at Lira and Soroti and the adjusted Wanzogi data.

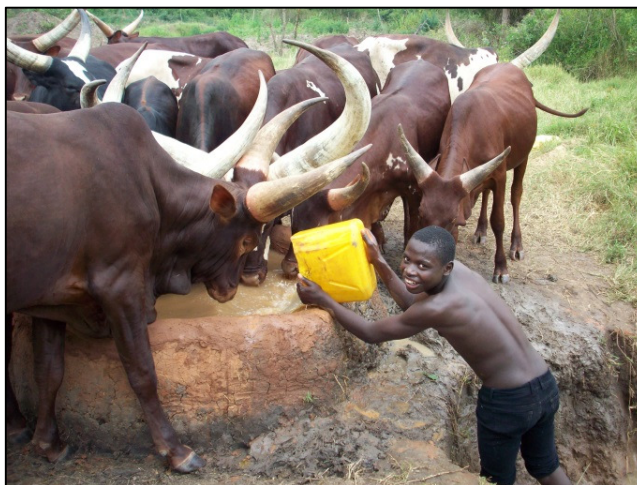
Figure 29: Local using a traditional trough standing inside the valley tank

animals from the traditional troughs – within the fenced area. The reason for these actions was that the provided pump could not keep up with the consumption rate of the cattle at the concrete trough. Hence, this trough was constantly almost empty and the calves were not able to reach the water. Furthermore it caused the herdsmen to take much longer

for watering their cattle which made them construct the additional traditional troughs. For the next dry season at the beginning of 2014, a new bigger pump will be organized to solve this problem. Half a year after the initial problems, during the short dry season of June and July 2013, the amount of cattle at the valley tank was low because many herdsmen still used small ponds on the farmland. Thus the amount of water pumped into the concrete trough was enough for that season's demand, yet due to mechanical problems the pump was out of use for almost half of that dry season. Since the distance from the trough to the valley tank is 30 m and carrying water with jerry cans is hard work, the herdsmen again shifted back to the use of their traditional troughs directly at the water body.
